Study: Comparative Nitrate Levels
in Cottonwood Creek, TX

Helen Arceneaux

4/21/14

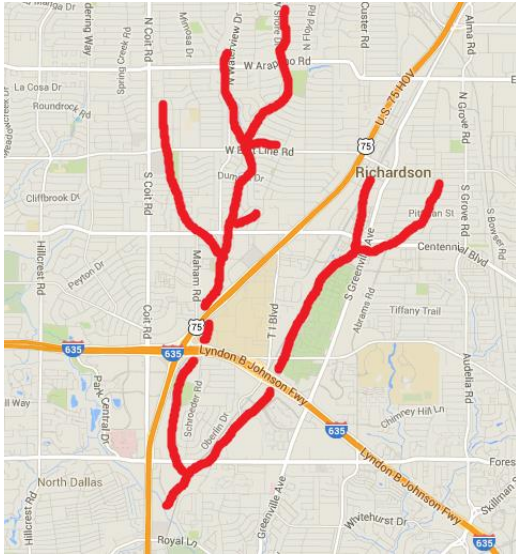
Figure 1: Map of Cottonwood Creek

The Cottonwood Creek watershed is located in Collin and Dallas Counties. While there is a tributary to Spring Creek by the same name, this creek has three separate headwaters which merge into the one creek. Two branches lay west of US Hwy 75 in the city of Richardson, TX. The third branch of the creek lay east of US Hwy 75 in the Dallas area. The confluence of Cottonwood Creek and White Rock Creek occur just north of the Forest Lane exit and US Hwy 75 adjacent to Cottonwood Creek Trail. The area of the creek is noted in figure 1. The drainage basin for Cottonwood Creek is classified as urbanized and is considered part of the Upper Trinity Watershed hydrologic unit HUC 12030105 as described by the USGS (EPA 1). The area of this hydrologic unit is 3582.1 km² (1383.6 mi²) (Gustafson 1). The Trinity River drainage basin starts in the North Texas area and drains to Galveston Bay as noted in figure 2.

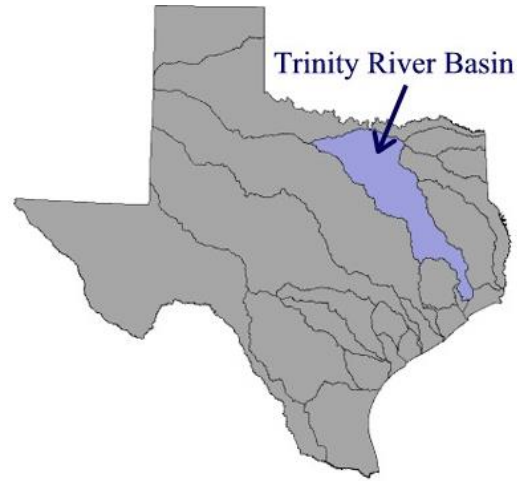
Figure 2: Map of the Trinity River Basin

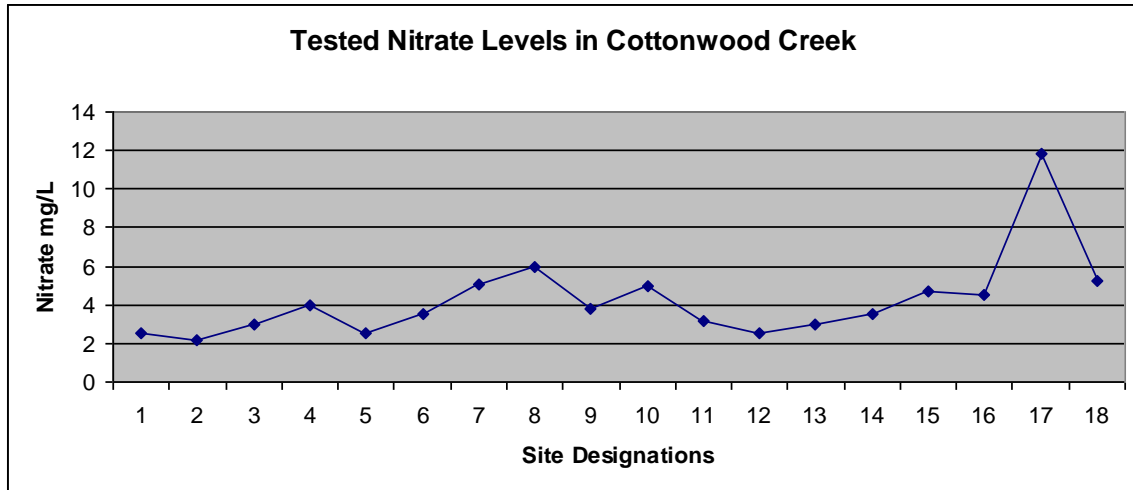
Each of the 18 test sites were evaluated for nitrate levels. Each test was run in triplicate and an average of the three obtained values were taken and documented. The averages are plotted in the graph below.

Figure 3: Nitrate levels in Cottonwood Creek

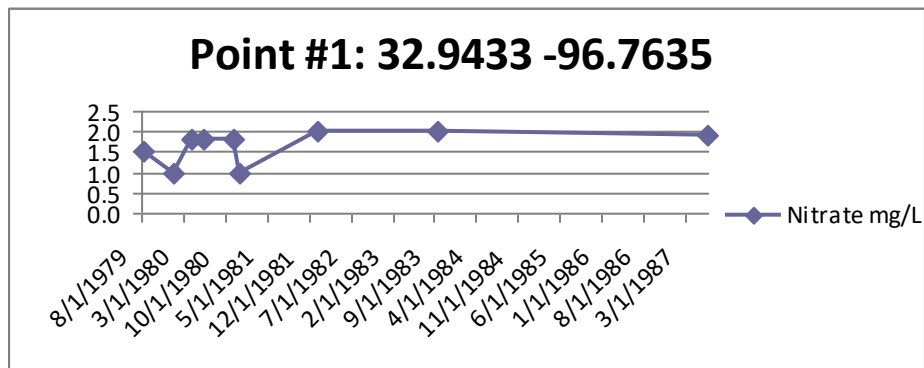
Fig 4. Point #1 Historical Levels: Hunt Branch

Historical data for points 1-3 are listed below. Graphs of historical data for the additional points are located in the appendix.

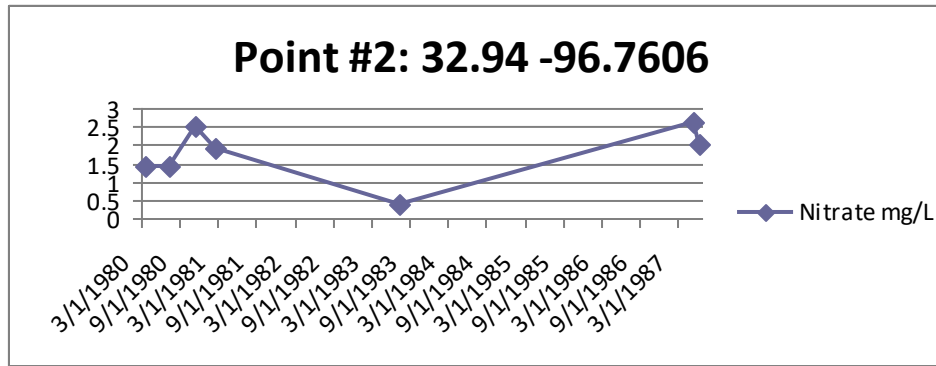
Fig 5. Point #2 Historical Levels: Hunt Branch

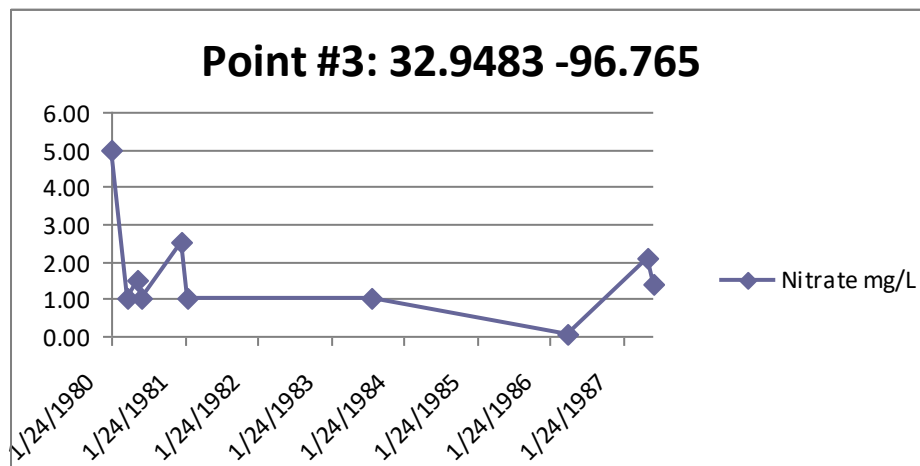
Fig 6. Point #3 Historical Levels: Hunt Branch

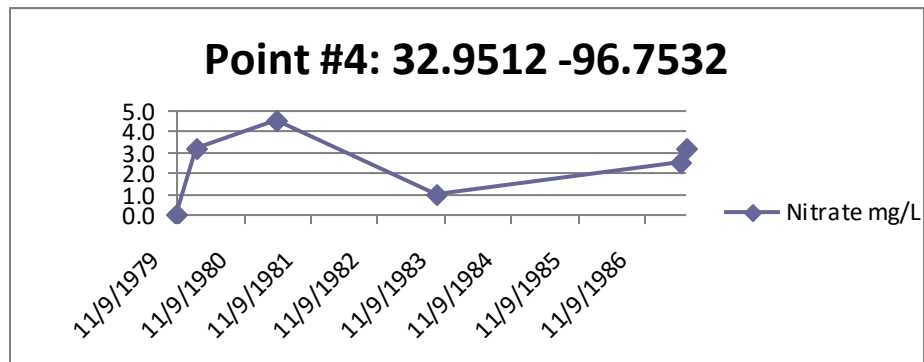
Fig 7. Point #4 Historical Levels: Main Branch

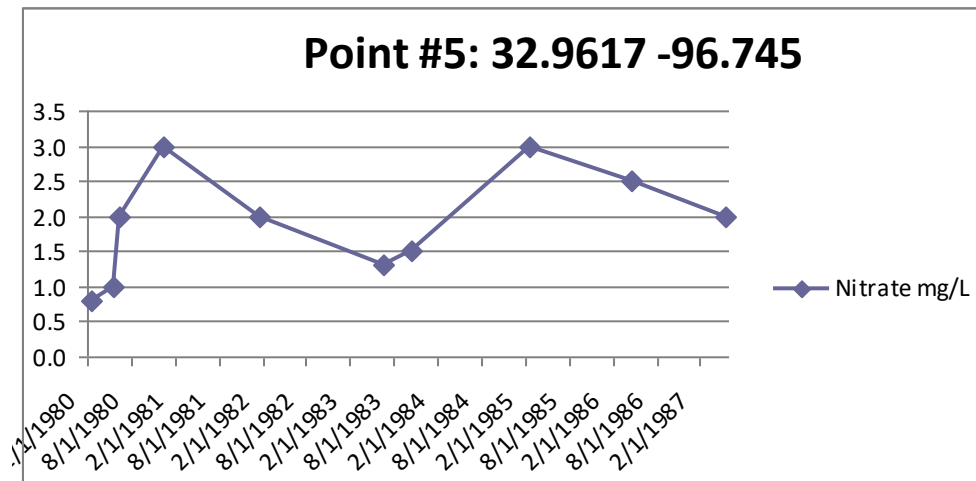
Fig 8. Point #5 Historical Levels: Main Branch

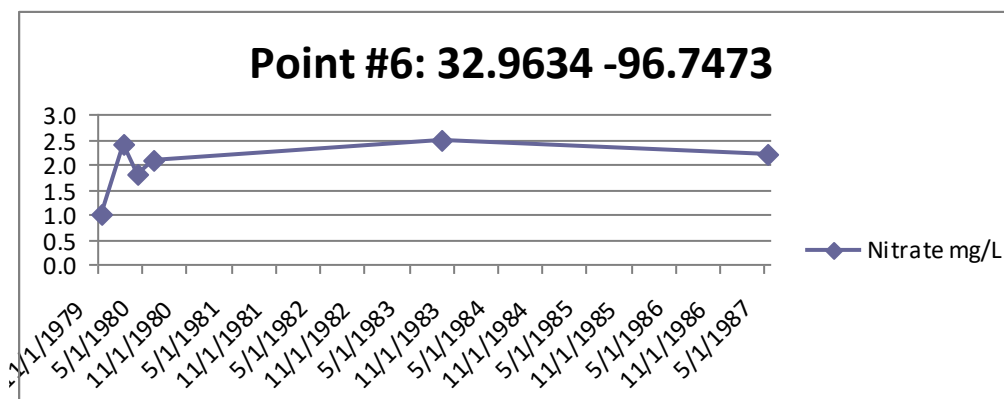
Fig 9. Point #6 Historical Levels: Main Branch

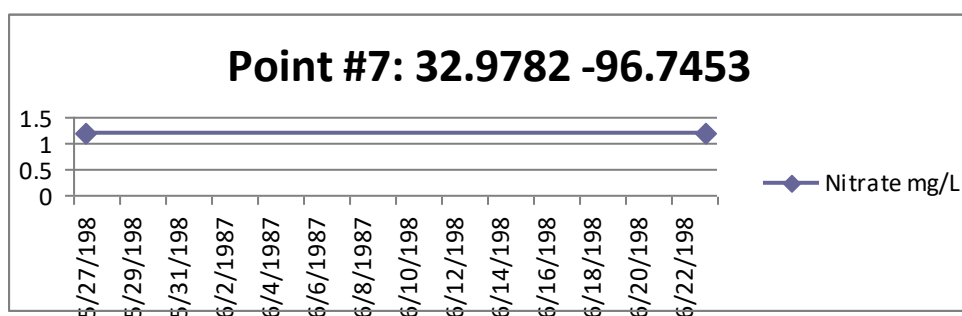
Fig 10. Point #7 Historical Levels located on Main Branch

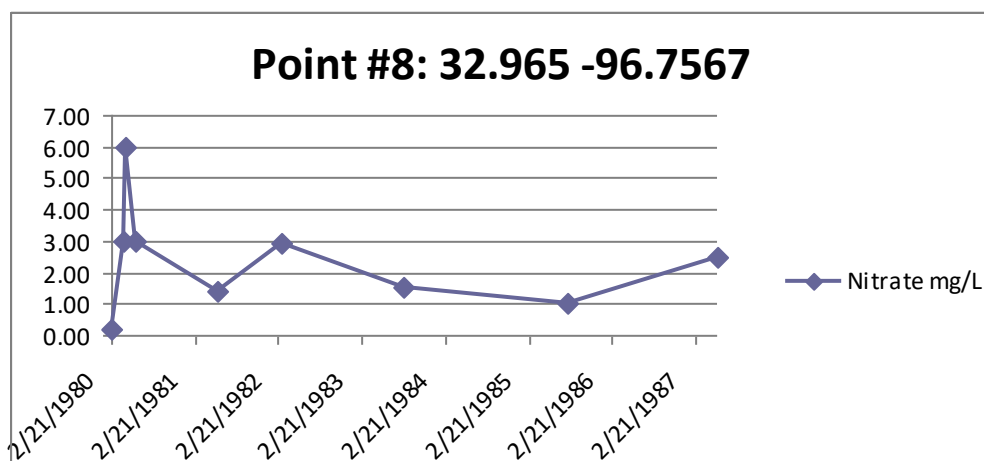
Fig 11. Point #8 Historical Levels: Main Branch

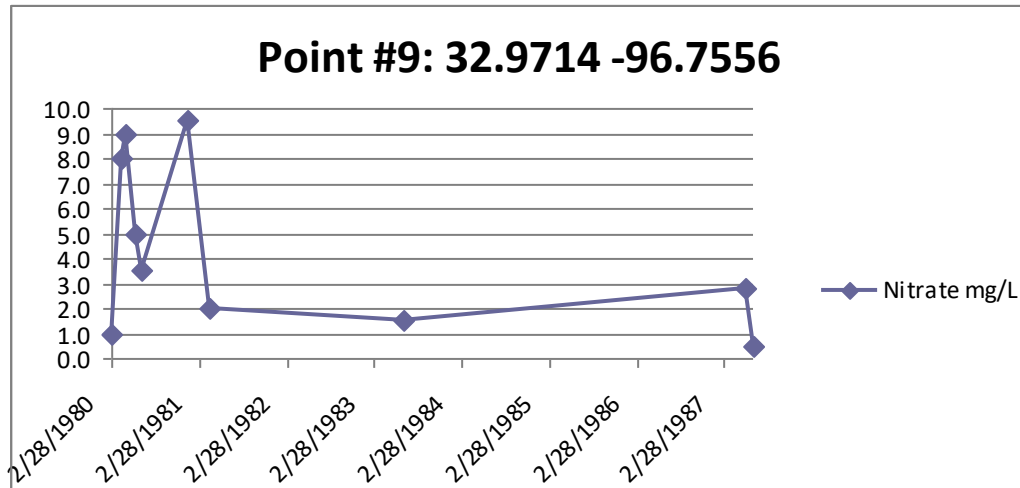
Fig 12. Point #9 Historical Levels: Main Branch

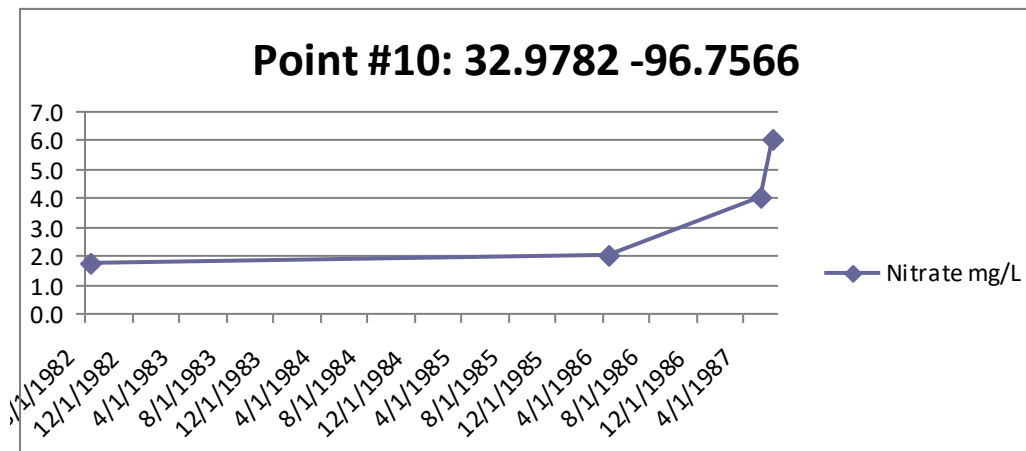
Fig 13. Point #10 Historical Levels: Main Branch

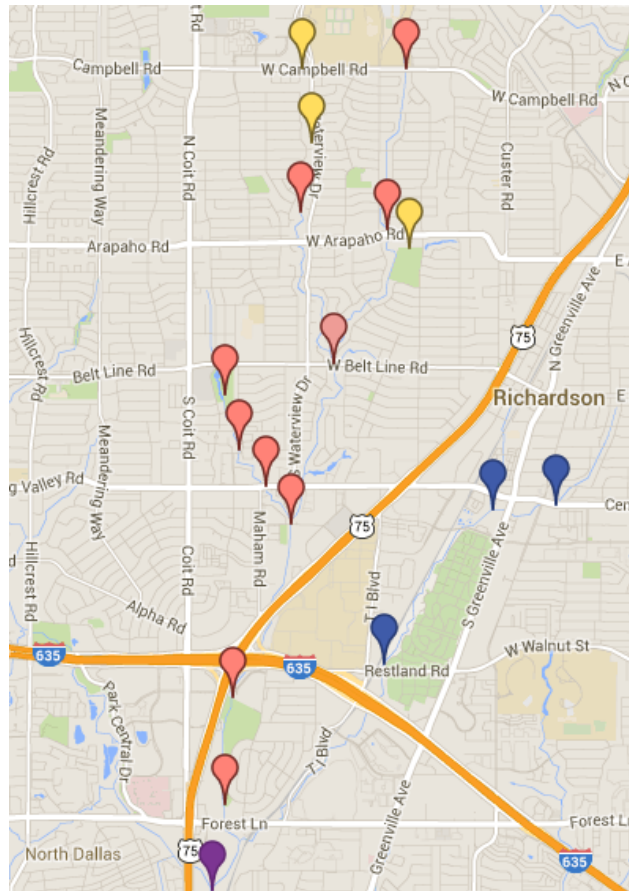
Fig 14: Historical Testing points plotted with Google Maps.
 Red- Hunt/Main Branches of Cottonwood Creek
 Blue- Floyd Branch of Cottonwood Creek
 Purple- Confluence of Cottonwood and White Rock Creeks

This was a field study conducted in the cities of Richardson and Dallas. Historical data for the desired creek was uploaded and then analyzed to find the exact latitude and longitude of each site. The sites were plotted in Google maps and scouted on the ground for accuracy prior to beginning the study. Each access point was documented by photograph for a total of 18 sites. The Hunt branch consisted of sites 1-3. The Main branch testing sites were numbered 4-11. The remaining testing sites, the Floyd branch of the creek, were delineated 12-18. A map including the tested creek points are listed in the Appendix.

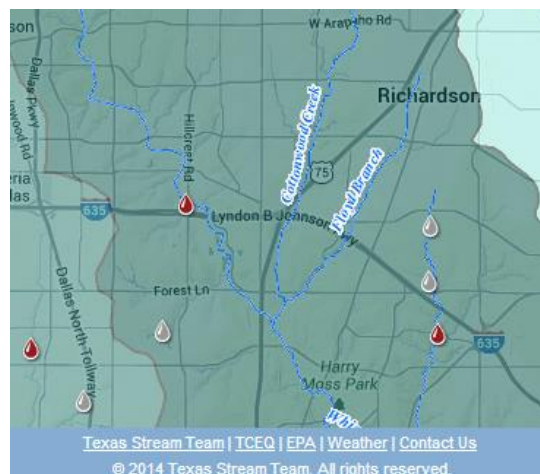
Fig. 15: Texas Stream Team Map of Cottonwood Creek

Sites 13-18 were chosen to test the third branch of the creek to compare to the other two branches. A map of Cottonwood Creek from the Texas Stream Team website is included (Fig. 2) to show a topographical view and the confluence with White Rock Creek (Texas 1).

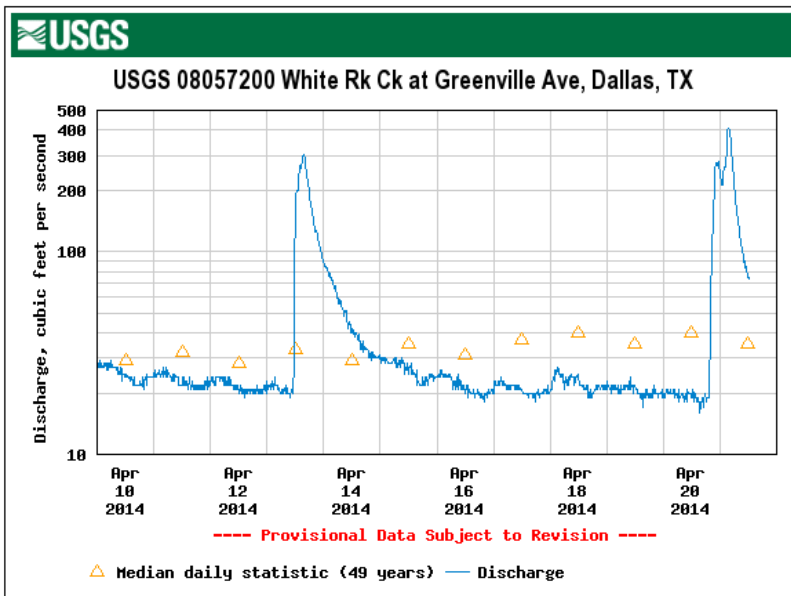
Fig 18: USGS White Rock Creek Discharge 4/10/14 - 4/20/2014

altitude of each site monitored to ensure the right location was sampled. Prior to sampling the sites were plotted on Google maps to determine the best point of entry into the segment of the creek being tested. A letter was obtained by a sponsoring professor in case access to private property needed to be requested. Additionally, the USGS White Rock Discharge summary was monitored to account for possible stream flow fluctuations from rain in the drainage basin. A copy of the discharge graphical data set is included in the appendix.
